Question 1: Compression sonography (left image) is the gold standard for the diagnosis of DVT. Are there any advantages of color Doppler ultrasound (right image) over compression sonography in the diagnosis of DVT?

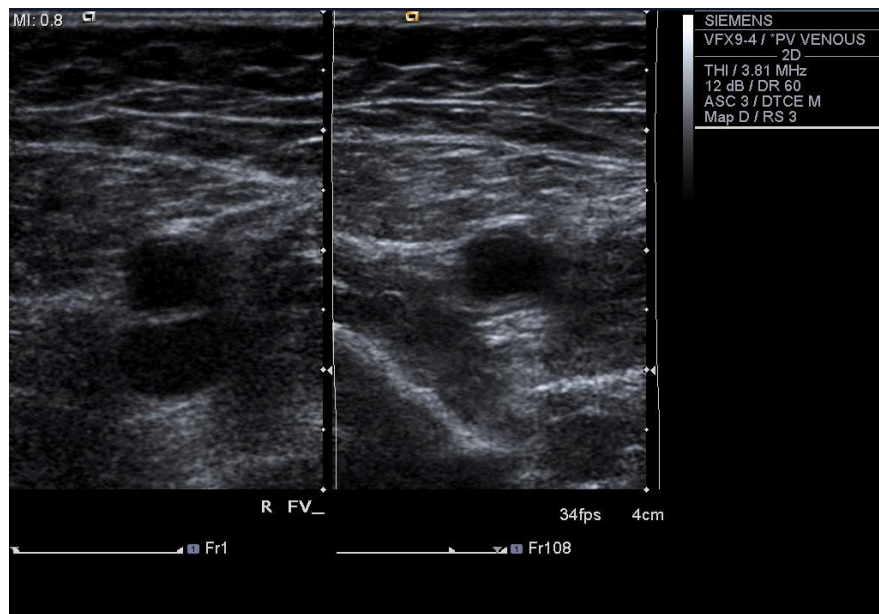
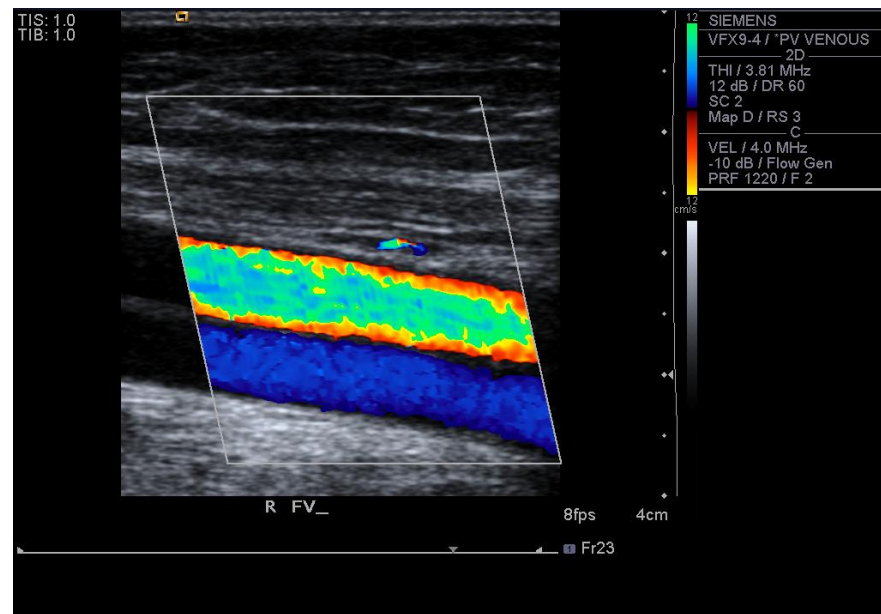
Model Answer: Color Doppler has several important advantages. First of all, color Doppler allows visualization of much larger segments of the vessel in one image. Secondly, color Doppler can demonstrate flow abnormalities in the vessel lumen due to small chronic thrombotic residua, fibrin or webs which could be easily overlooked during compression sonography. Color Doppler is more sensitive (longer pulses -> greater duty factor -> better signal to noise ratio) and can easily demonstrate flow in areas which are difficult or impossible to adequately visualize on 2D ultrasound, particularly vessels in large patients, patients with oedema or patients with unfavourable acoustic properties. Finally, basic flow characteristics such as phasicity or pulsatility can be observed on color Doppler whereas 2D ultrasound provides only anatomical information. For these reasons, continuous color Doppler examination of the deep veins should always be performed when assessing the deep veins for DVT.

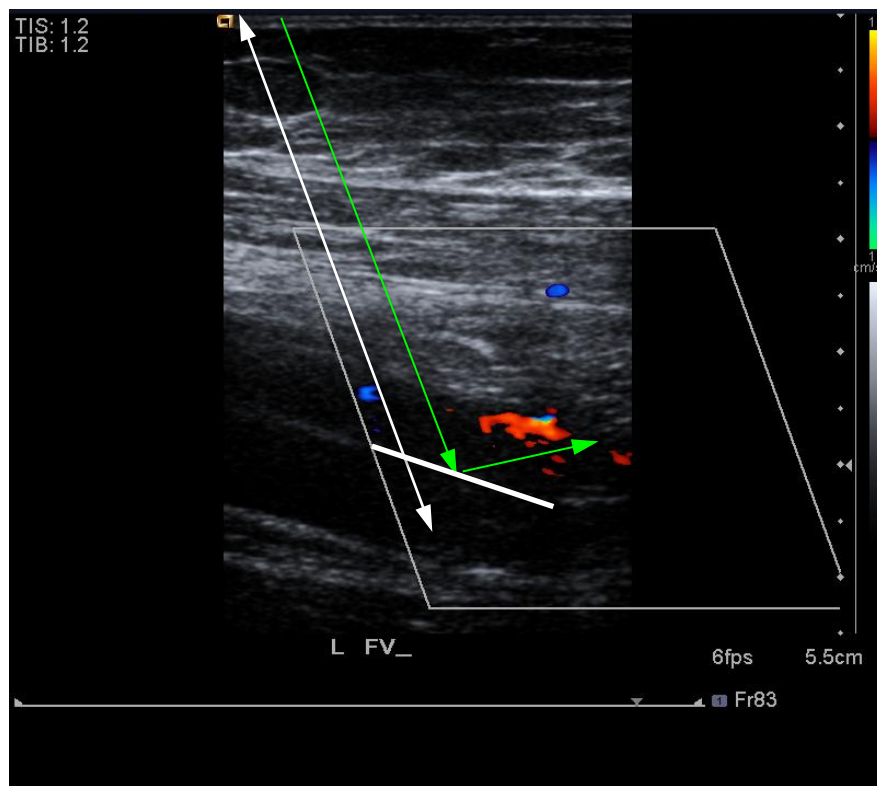
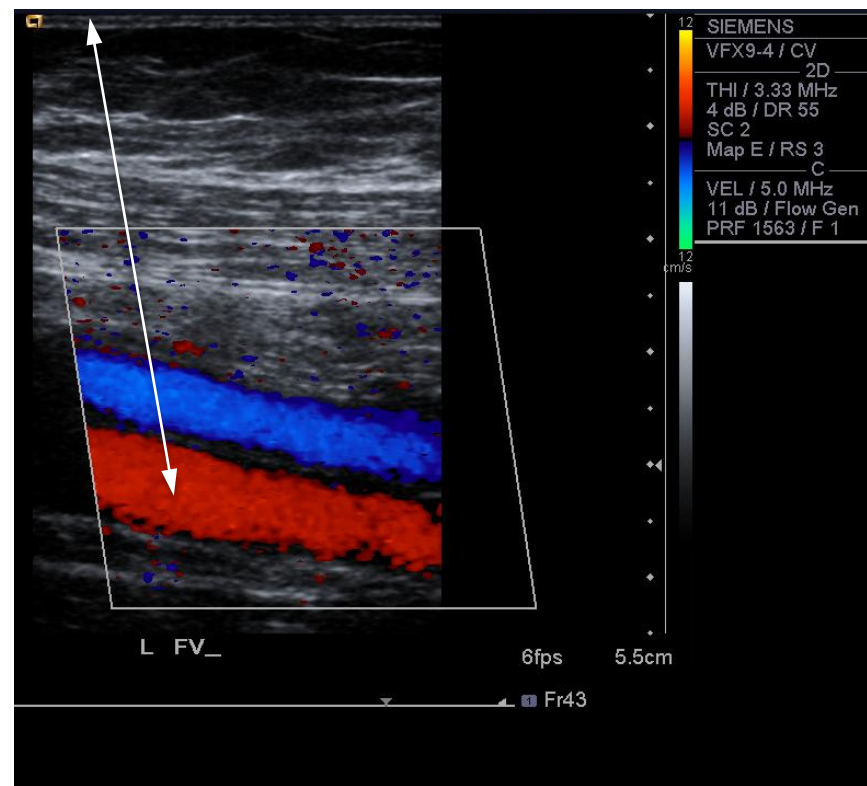
Question 2: For the same sample site in the same vessel, Doppler shift is angle dependent. The higher the Doppler angle, the lower the Doppler shift. The two color Doppler images of the Femoral Artery and Vein below were obtained at the same site. No system settings were changed between the two images apart from beam steering. Why does the color Doppler image on the right show better sensitivity to flow despite a higher (more obtuse) Doppler angle?

Model Answer: The left image is obtained at a more favourable Doppler angle and the Doppler shifts generated by flow in the Femoral Artery and Femoral Vein will be higher. However, due to the beam steering and deep location of the vessel, the beam path is longer, so the beam will suffer greater attenuation therefore reducing the sensitivity (white arrows). Additionally, the acute angle at which the beam strikes the vessel wall may sometimes lead to a critical angle problem where the beam reflects off the wall without penetration into the vessel (green arrows).

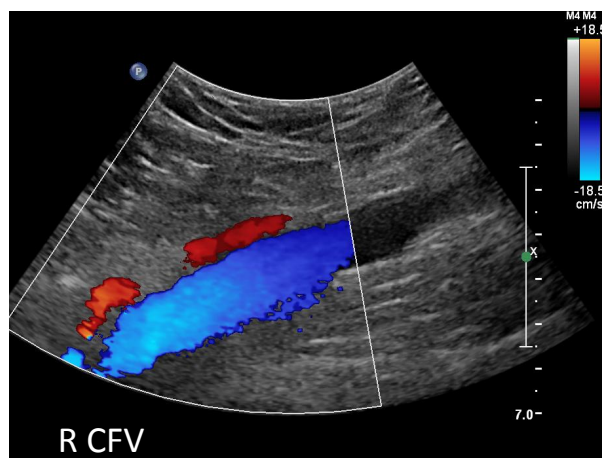
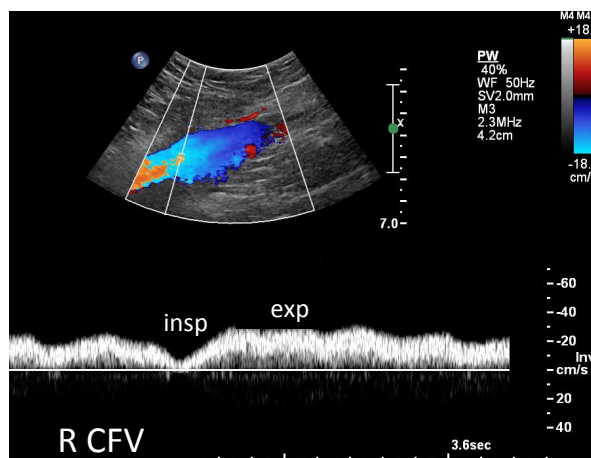
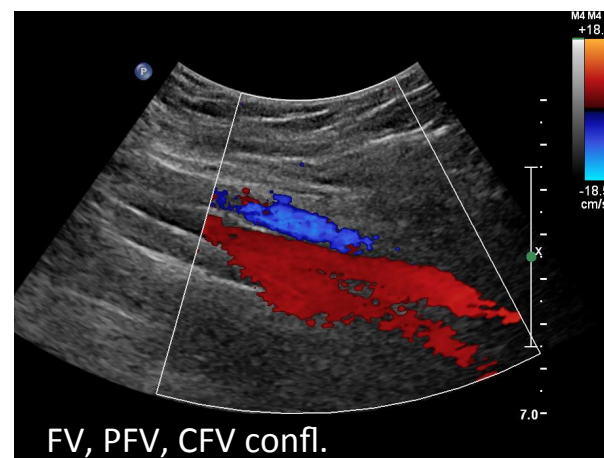
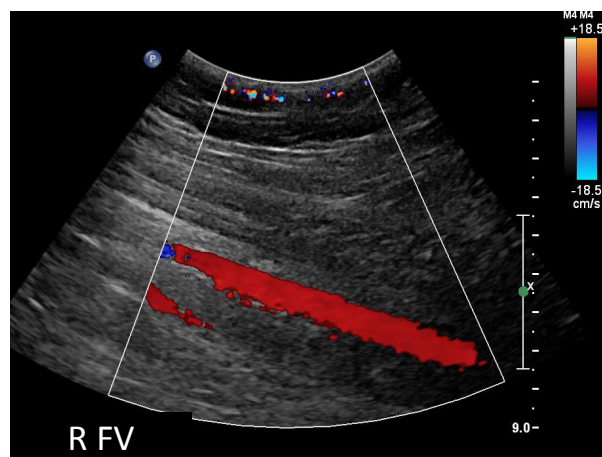
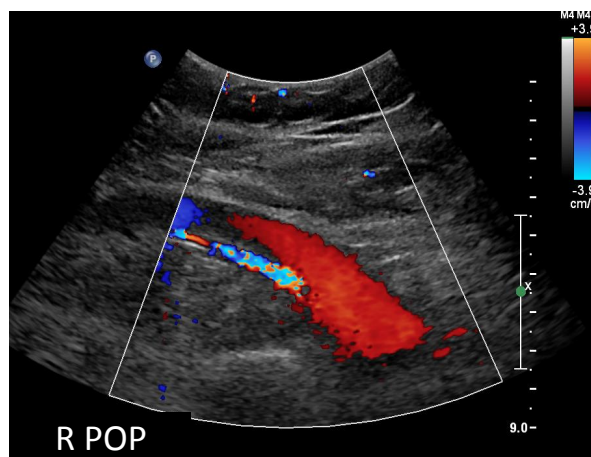
Question 3: The sonographer is performing a lower extremity “DVT scan” in a morbidly obese patient with acute weeping cellulitis in the calf. The calf is not scannable at all. Review the study the sonographer has performed. What comments can be made about this study?

Model Answer: In terms of the deep veins, the sonographer here has done all that was reasonably possible and has used a low frequency curvilinear array transducer to image the vessels. All vessels are widely patent on color Doppler and demonstrate good fill and consistent smooth flow characteristics. Isolated calf DVT cannot be excluded on this study because the calf is not accessible.

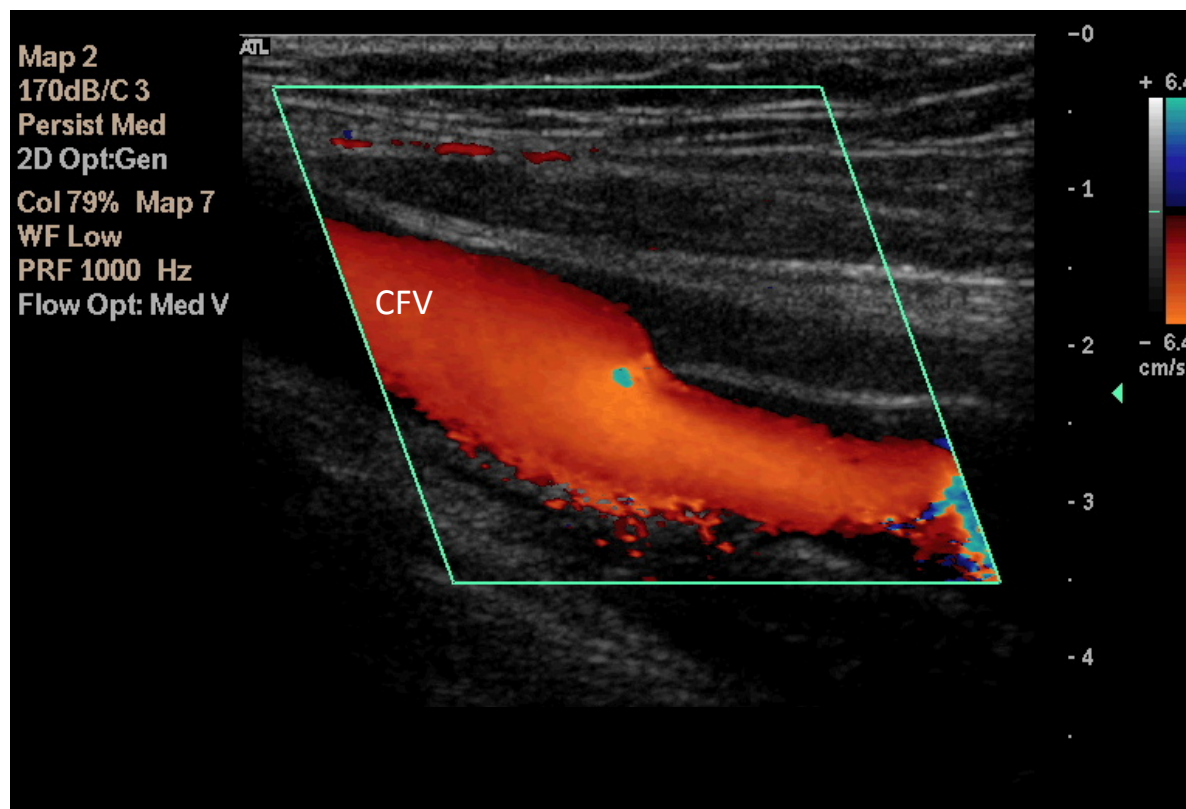
Model Answer: There is occlusive DVT involving the Femoral vein to the level of the PFV-FV confluence. Because the femoral vein is smaller than the PFV, it is likely the DVT is not acute.

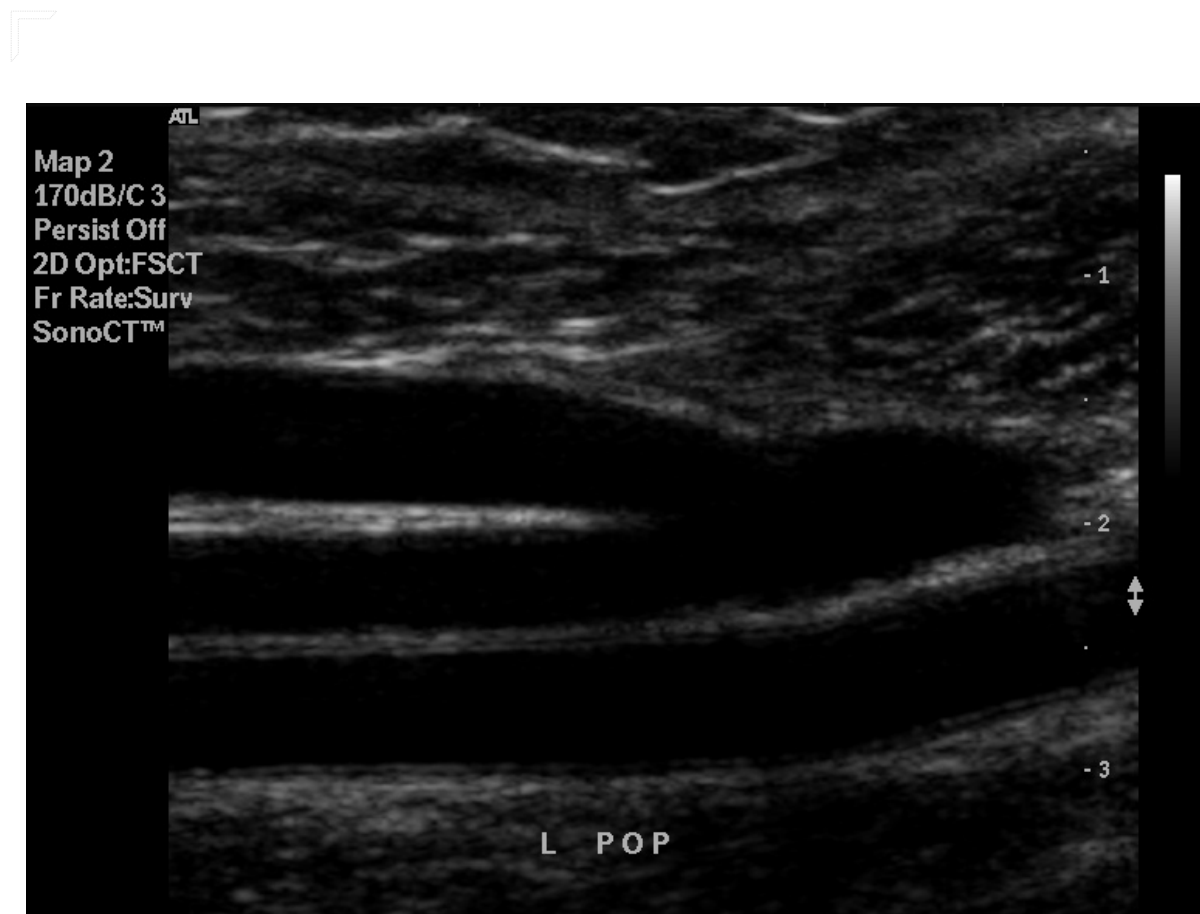
Model Answer: There is a duplication of the superior portion of the L POP vein in this image which is a normal anatomical variant present in approximately 20% of the population.

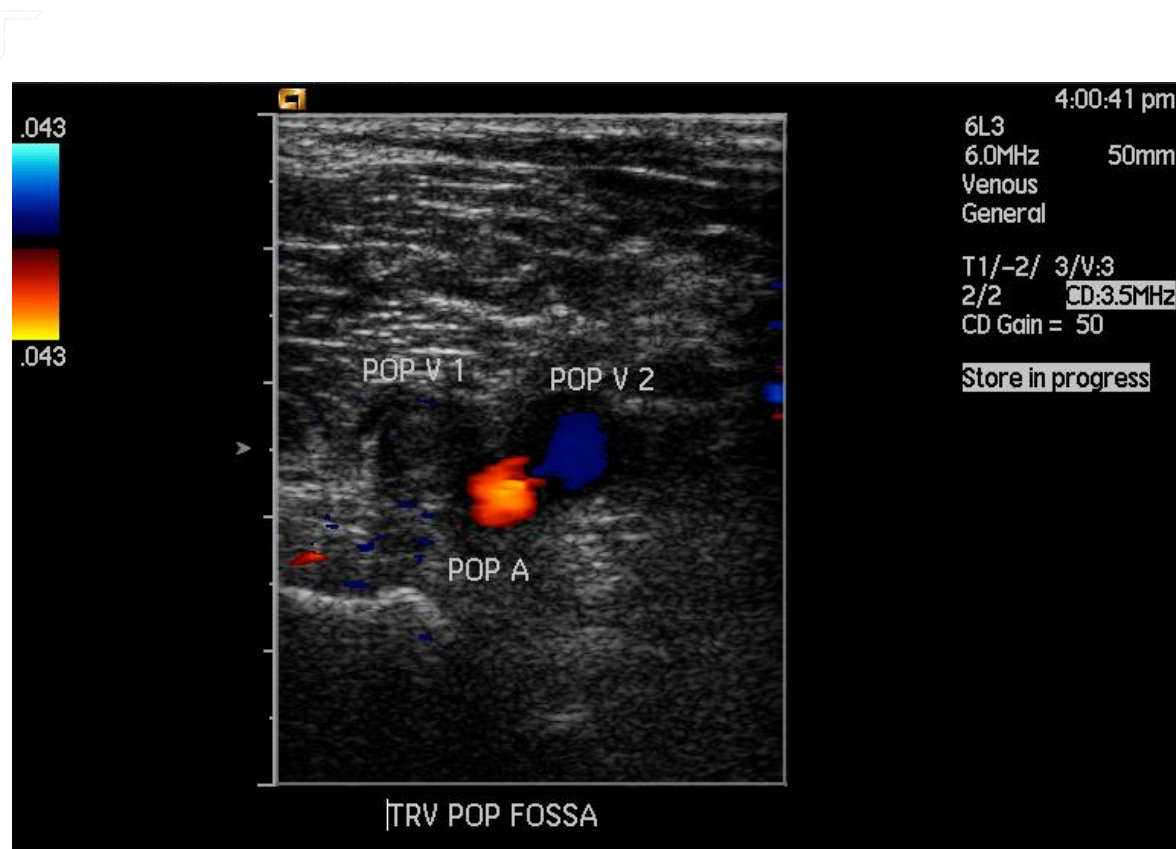
- Model Answer:
- Acute occlusive DVT is seen in one of two Popliteal Veins in this patient.
 - The operator is holding the transducer in transverse section of the Popliteal fossa but the transducer is angled inferiorly. With this approach, arterial flow passing through the scanplane generates a negative Doppler shift and the Popliteal artery is correspondingly displayed in Red color.

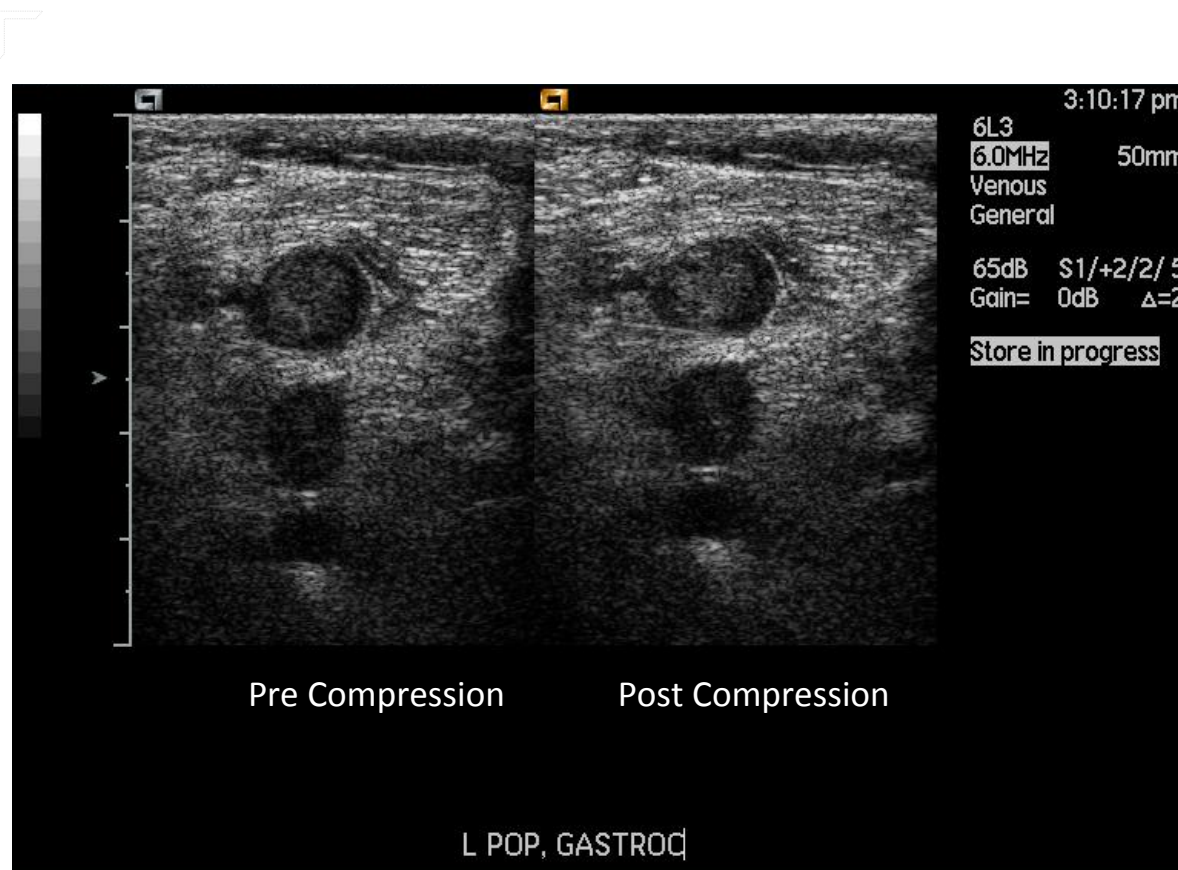
Model Answer: Acute DVT is seen in the Popliteal vein as well as the Gastrocnemius trunk.

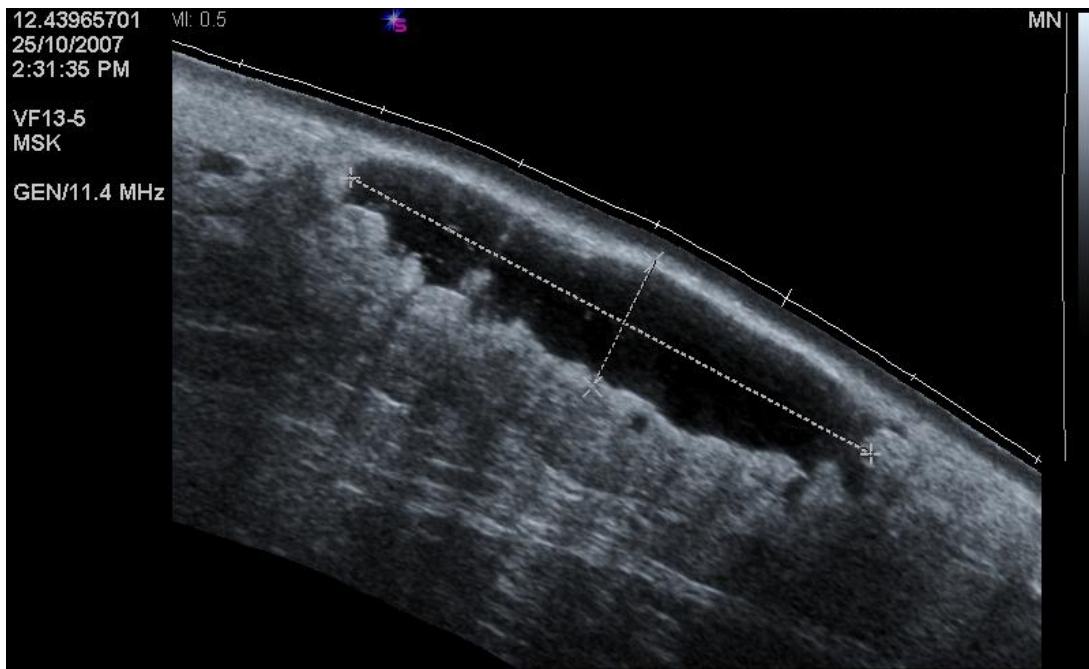
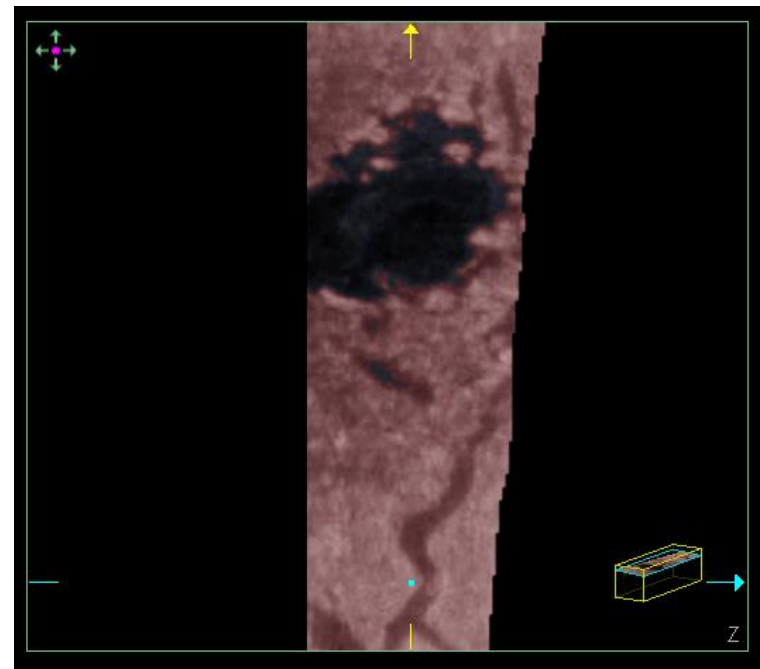
Model Answer: The area of interest demonstrates an irregular fluid-filled subcutaneous collection spanning some 4cm in width (see calibration marks on image) and 1cm deep. There is no discrete capsule or wall around the fluid. Ultrasound findings in combination with patient's clinical history strongly suggest the presence of a subcutaneous abscess.

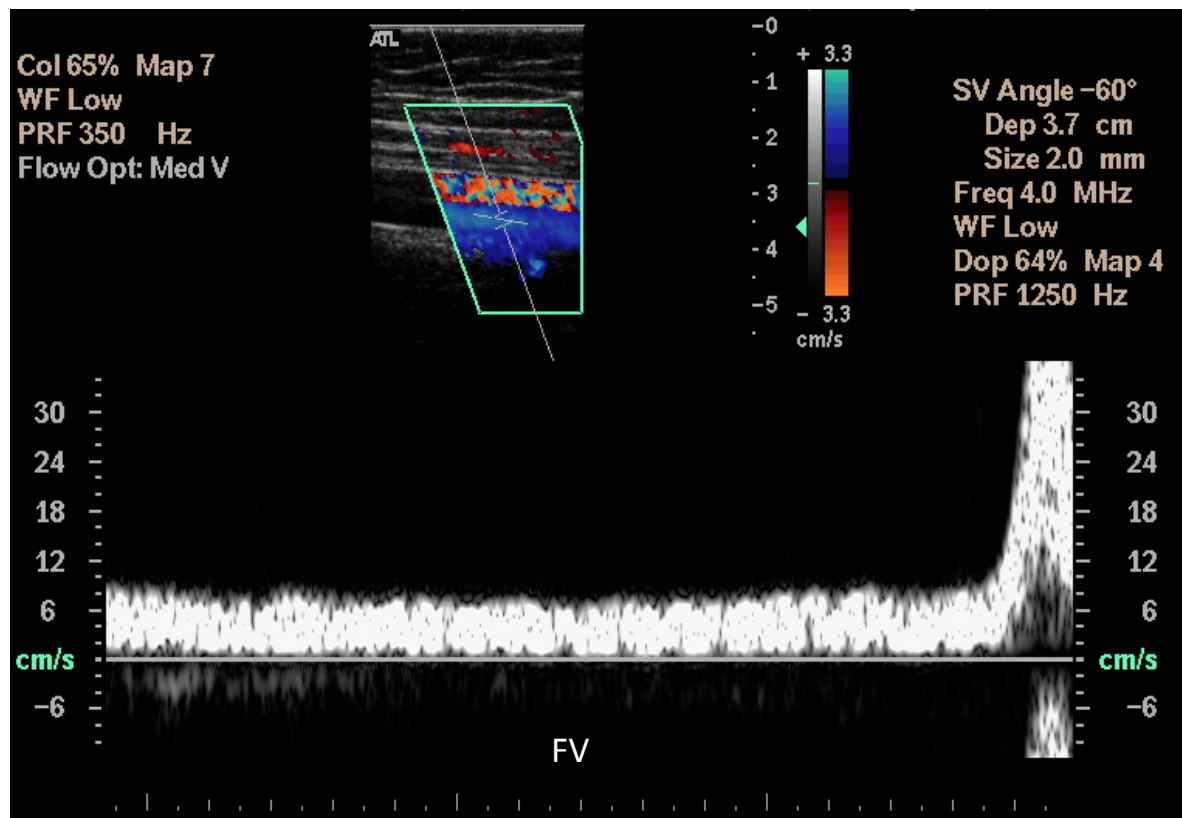
Model Answer: Flat aphasic augmentable flow is seen on this spectral trace of the Femoral Vein. The finding is suspicious for downstream venous obstruction. This could include proximal DVT or mechanical compression of the vessel by surrounding structures including May-Thurner Syndrome, Pregnancy, Pelvic or Abdominal mass.

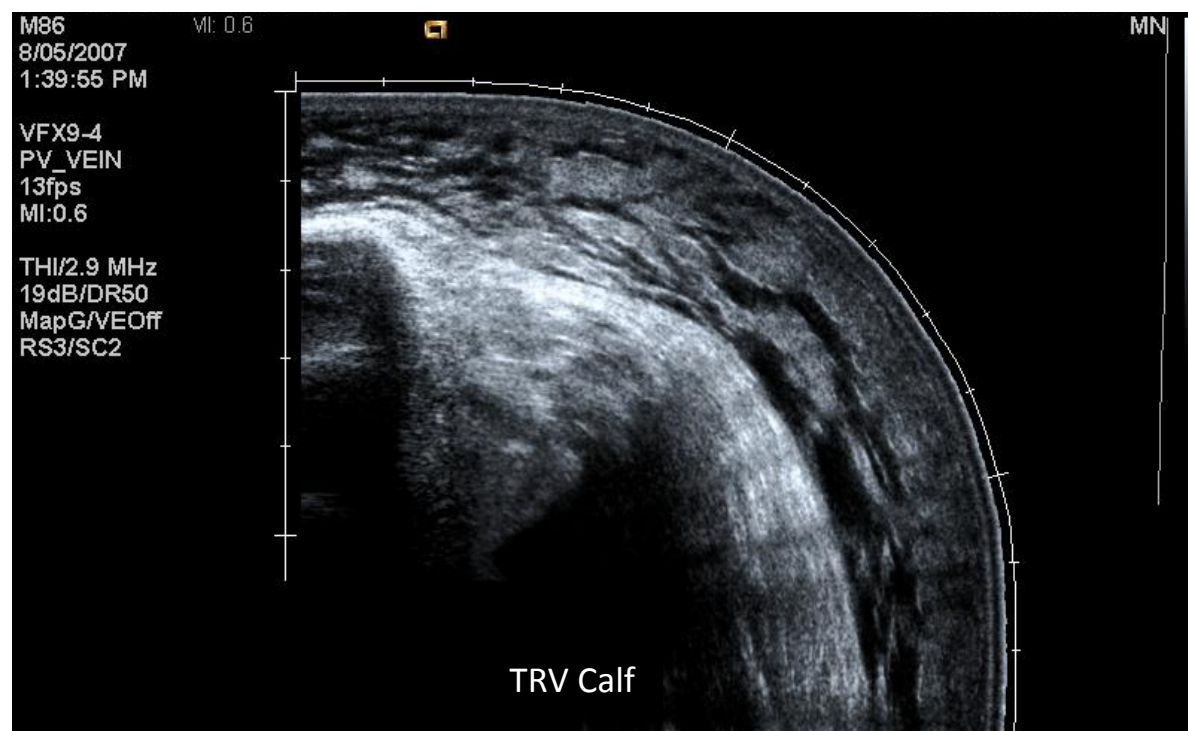
Model Answer: This panoramic image of the superficial soft tissues of the calf demonstrates subcutaneous oedema. Nothing more can be learned about its cause from this single image. In this case, the patient presented for DVT scan due to bilateral leg swelling. The DVT scan was negative, but the patient was noted to be in advanced stages of heart failure.

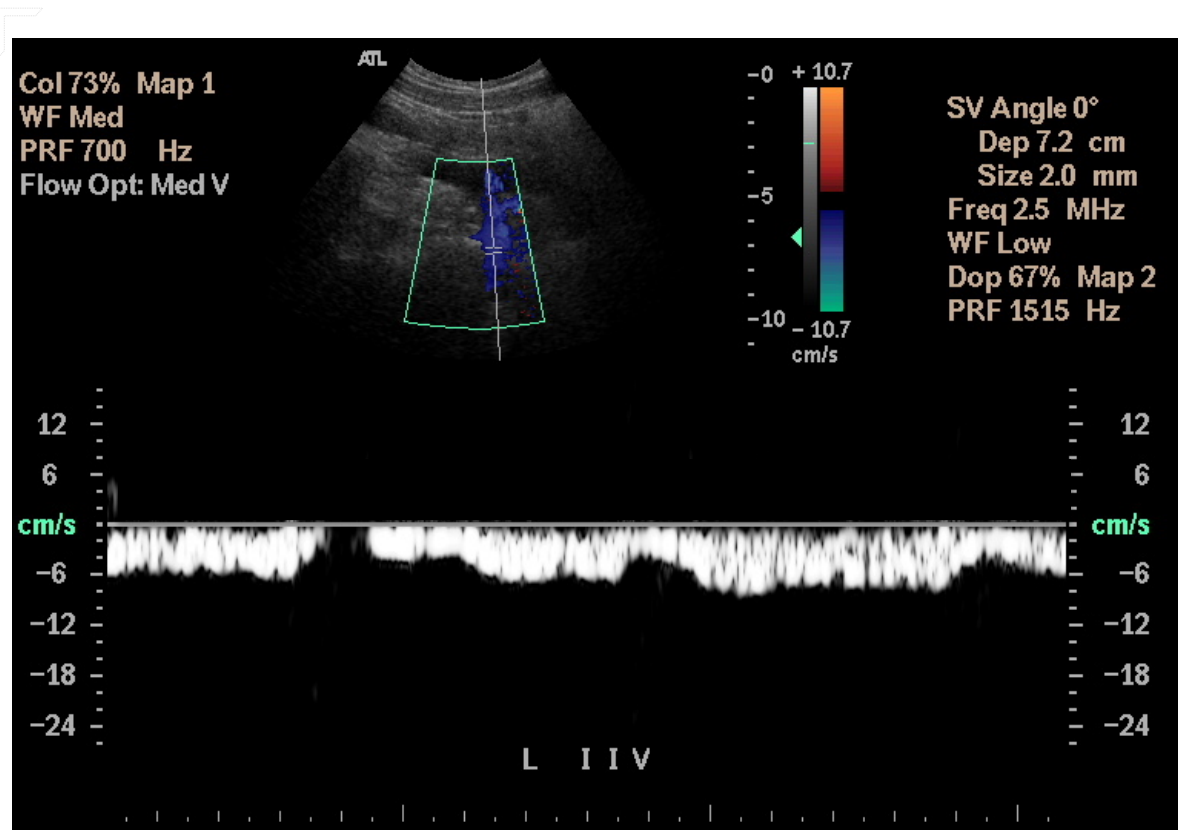
- Flow in the Internal Iliac vein demonstrates continuously reversed flow. The patient has internal iliac vein incompetence.
- There may be several several reasons to assess the IIV. The IIV may act as a collateral in a patient with downstream DVT (such as occlusive DVT of the CIV) so the IIV may have been assessed for this reason. But perhaps a more common reason to scan the IIV is during venous assessment of pelvic veins in women suspected of pelvic venous competence, pelvic

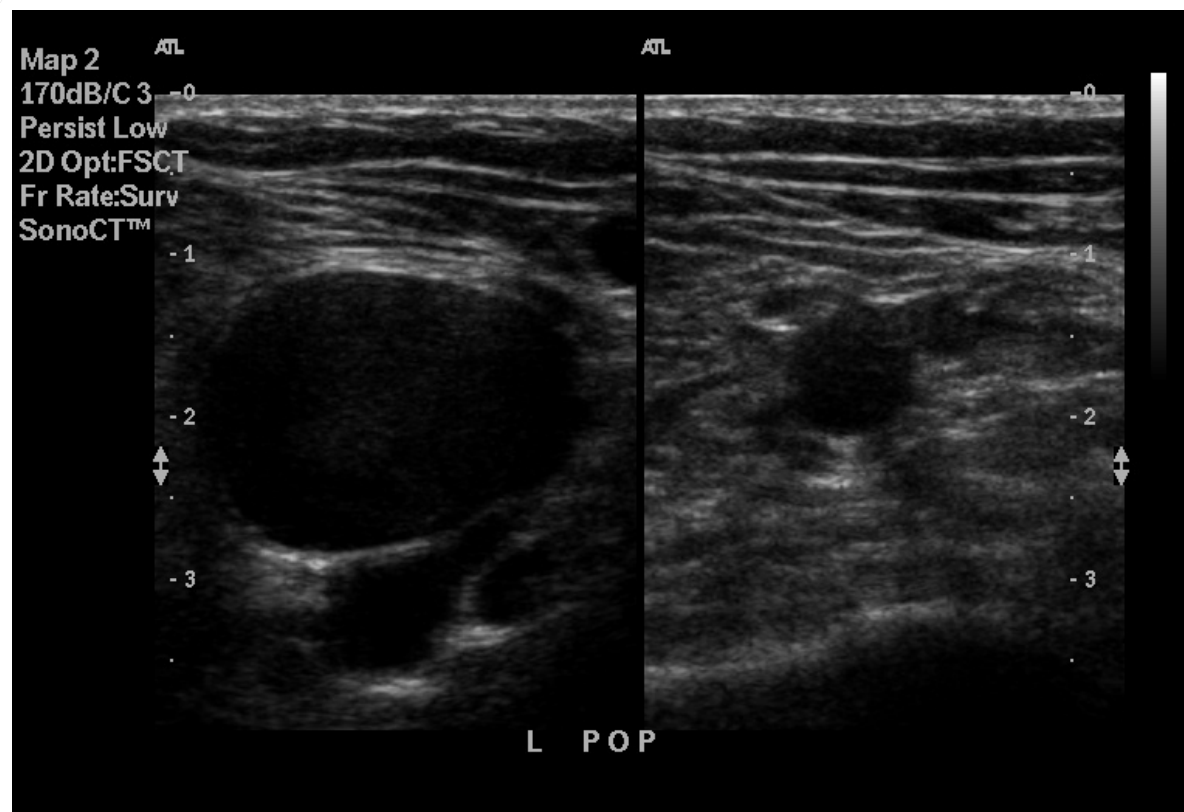
The Popliteal vein is large in diameter measuring nearly 20mm in transverse section in comparison with the Popliteal Artery at less than 10mm. The Popliteal vein is completely compressible. While benign Popliteal vein ectasia is sometimes encountered, focal increase in Popliteal vein diameter with diameter over 20mm should raise suspicion of Popliteal vein aneurysm. Beyond 20mm diameter, there is an increasing risk of thrombosis. The patient should be referred for vascular surgical opinion. Despite its large size, an ectatic or aneurysmal Popliteal vein is usually competent.

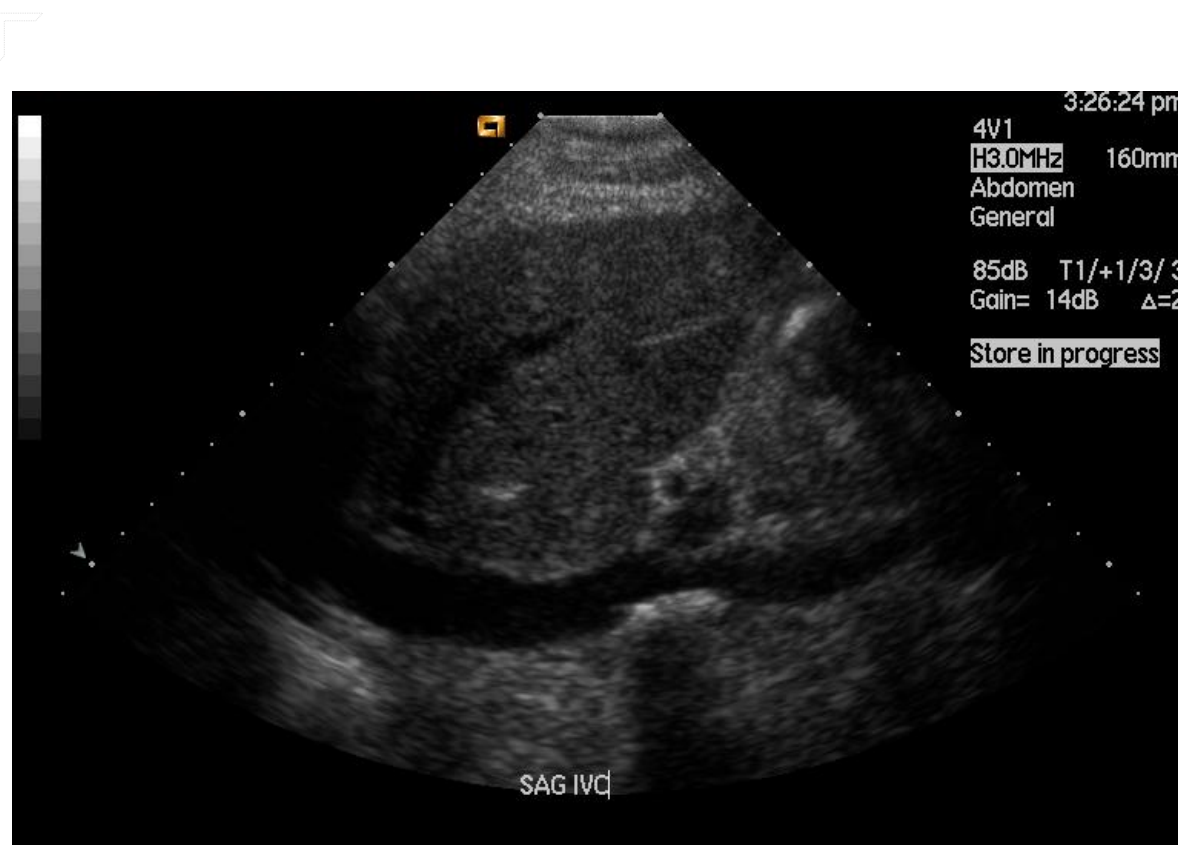
Model Answer: Sagittal view of the IVC demonstrates an echogenic shadowing focus along the posterior border in line with the inferior border of the liver. Appearance is consistent with a phlebolith.

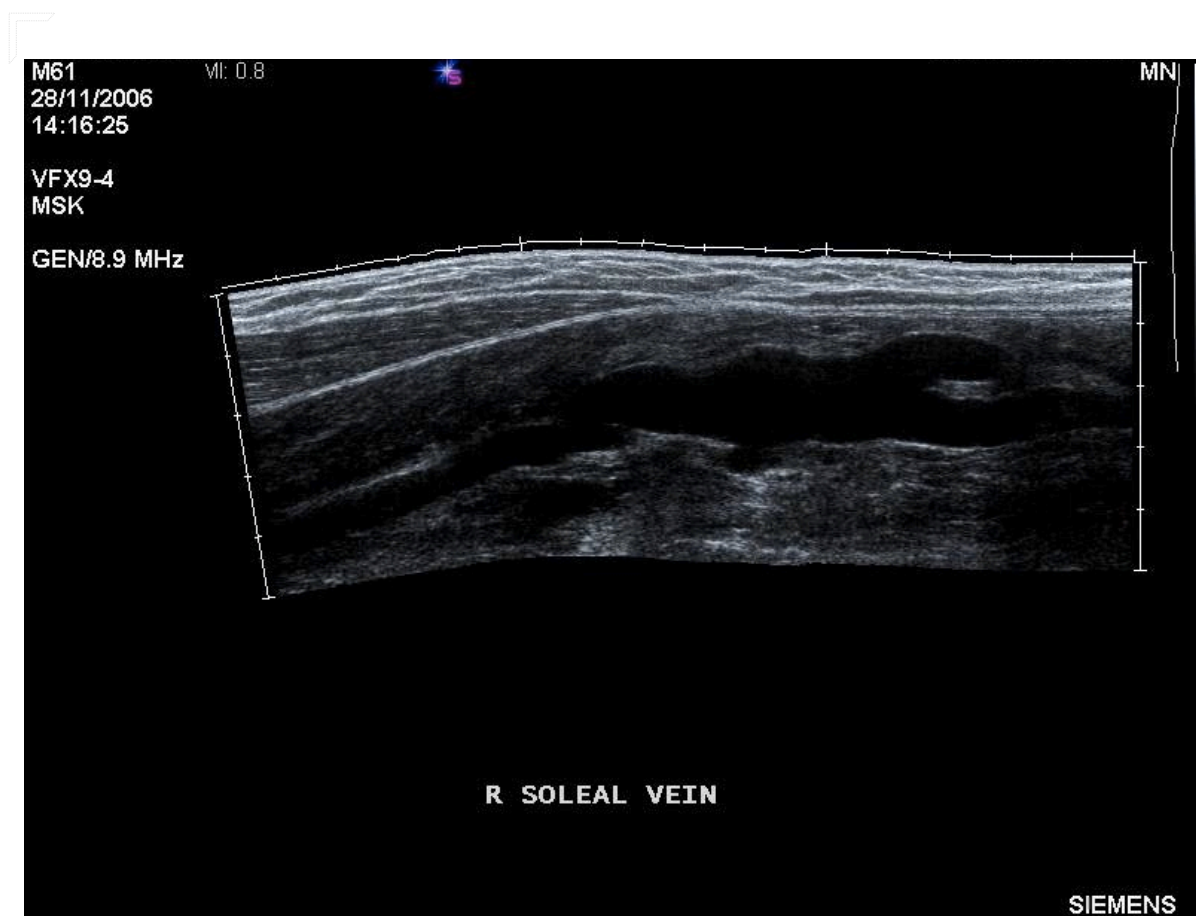
Model Answer: There is general dilation of the distal Soleal veins. The appearance can represent benign Soleal vein ectasia, but it can also be seen in patients with incompetent distal Soleal perforator(s). The veins should be assessed for competence and their peripheral extent should be scrutinized for the presence of associated incompetent perforators.

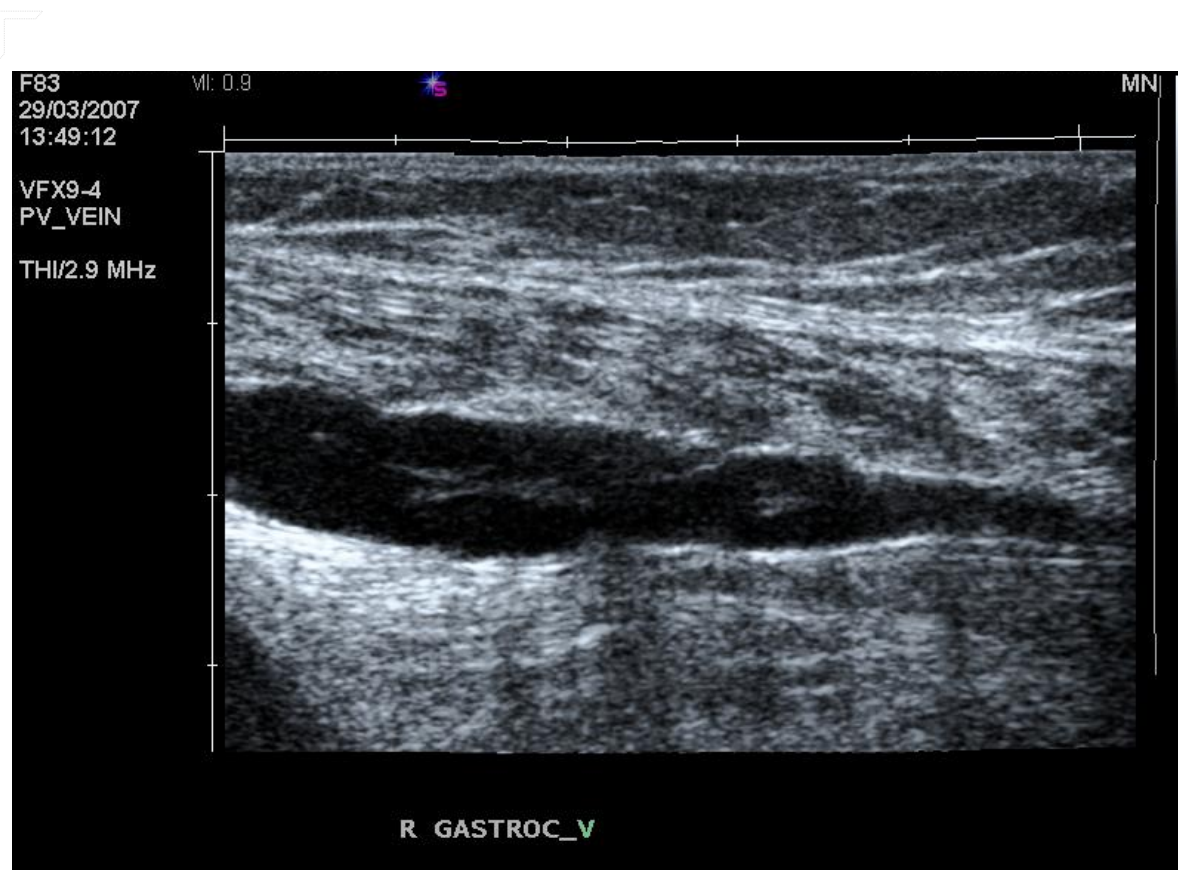
Model Answer: Echogenic linear intraluminal echoes of varying thickness are demonstrated within the Gastrocnemius vein. Appearance is consistent with chronic thrombotic residua and fibrin strands.

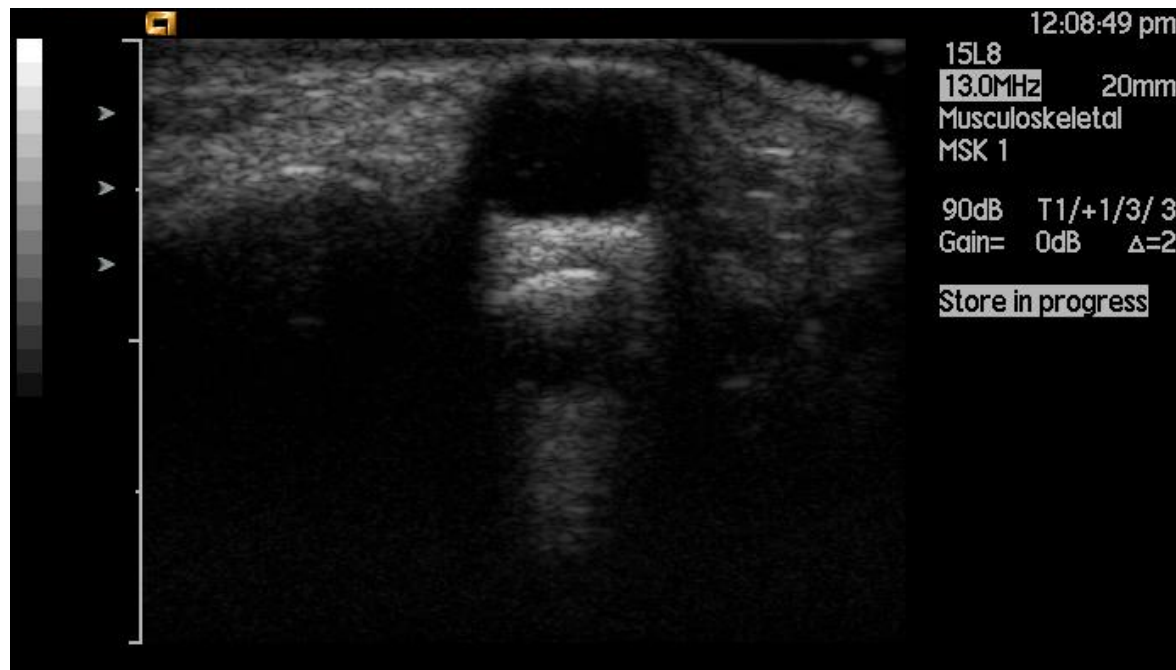
Question 16: Patient with extensive varicose veins complains of a painless palpable lump over the anterior aspect of the ankle. Ultrasound reveals an avascular round mass as shown below. Describe the image and give the most likely differential.

Model Answer: The palpable mass appears as an anechoic round simple cystic lesion associated with underlying ankle joint structures. In the vicinity of joints and synovial sheaths, a ganglion is a likely differential.

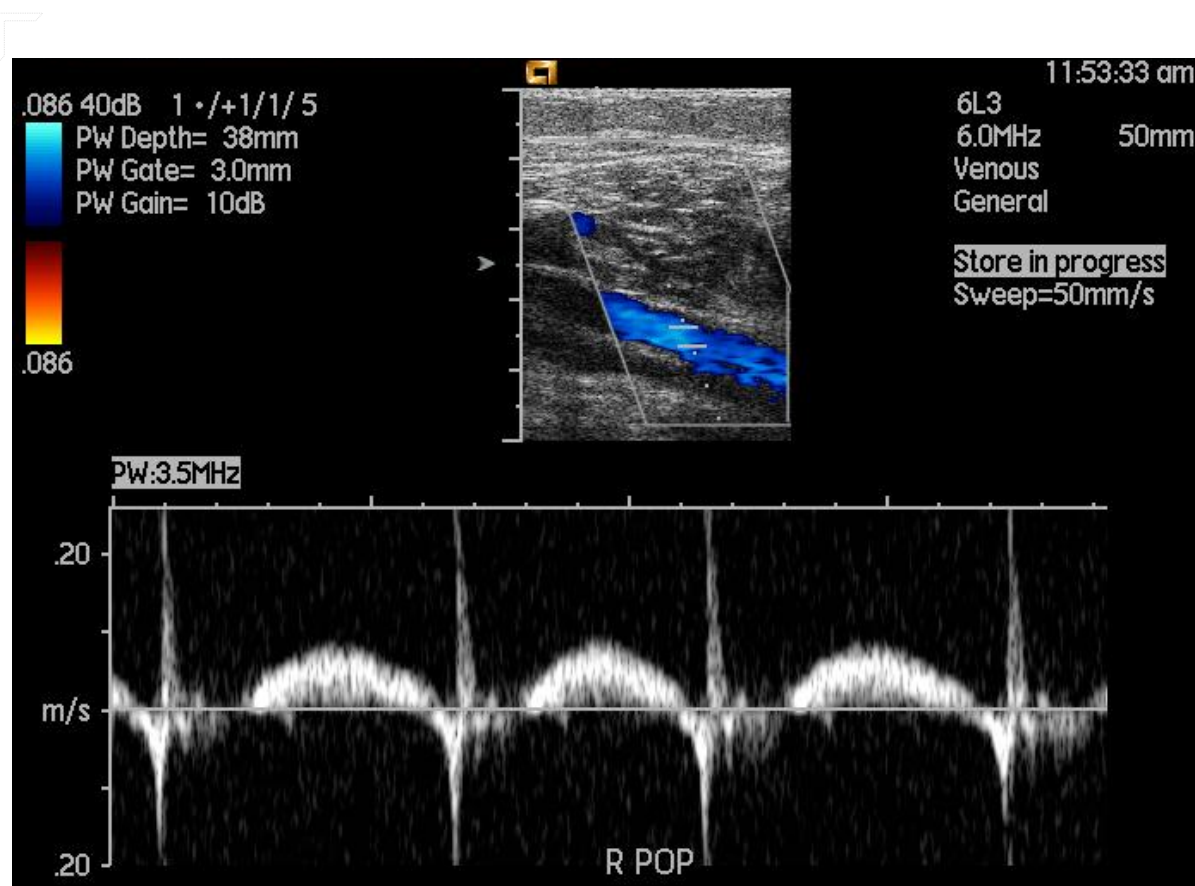
Model Answer: Spectral Doppler waveform of the Popliteal vein is highly pulsatile. This is a sign of high central venous pressure commonly due to right heart failure or profound trisupid regurgitation.

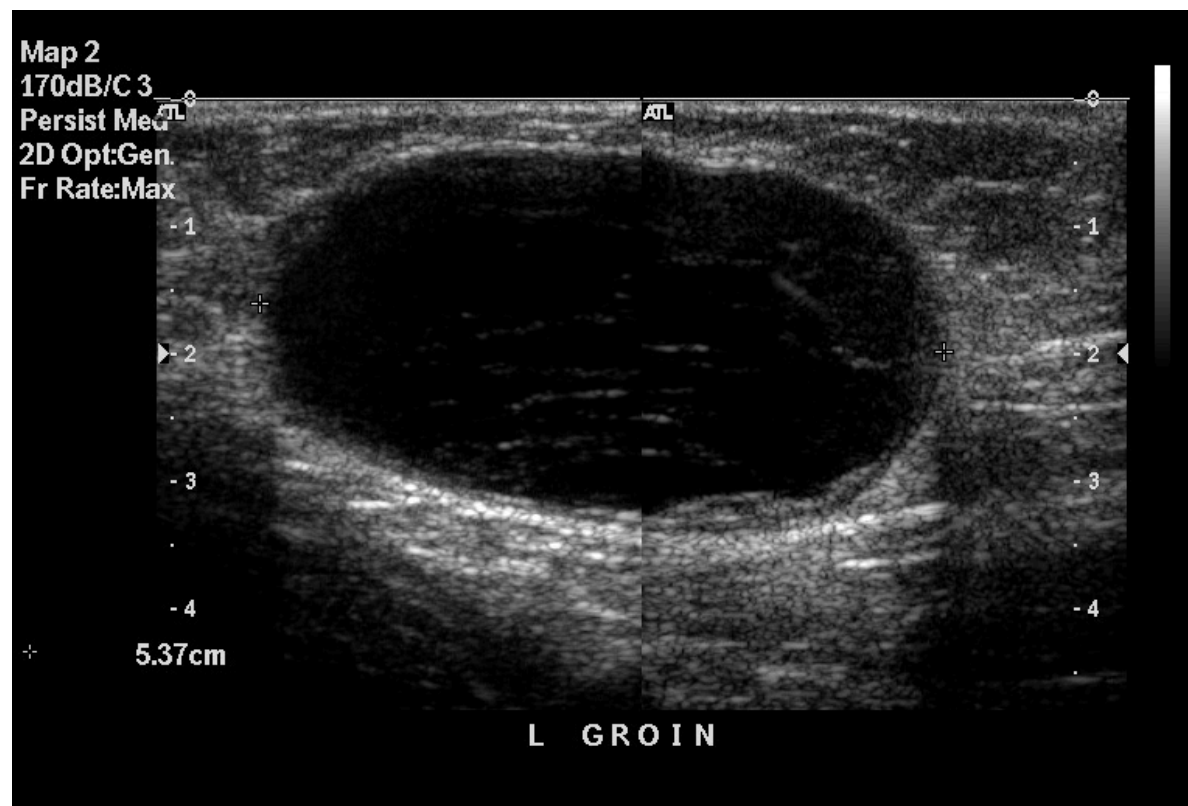
Question 18: A groin lump is detected during duplex scan of the lower extremity. On questioning the patient reports it has been there for about a year ever since she had cardiac interventions following an MI. Describe the image and provide a diagnosis.

Model Answer: There is a oval well defined and well marginated lesion with a thick capsule and anechoic internal contents criss-crossed by a reticular pattern of fibrin strands. Appearance is characteristic of a hematoma.

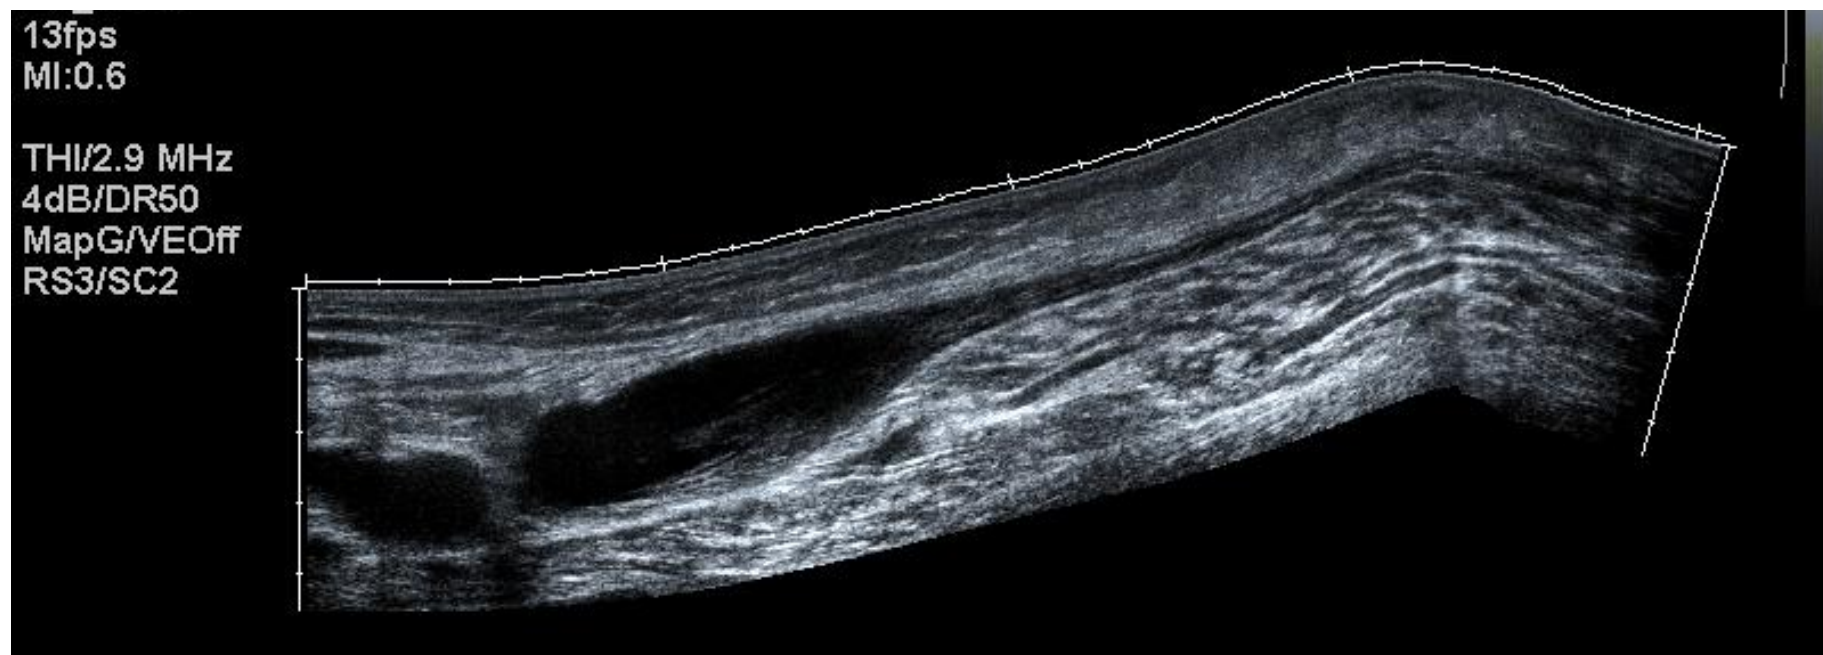
Question 19: A patient presents with hard swollen calf. The following panoramic view was obtained along the medial aspect of the calf from the knee peripherally.

Model Answer: Panoramic image of the medial calf structures demonstrates a bi-lobed fluid collection at the level of the knee with a thin extension propagating peripherally along the fascial planes of the gastrocnemius muscle. Associated subcutaneous oedema is seen in the dependent part of the calf. Findings are characteristic of a ruptured Baker's cyst.
