Question 1: Compression sonography (left image) is the gold standard for the diagnosis of DVT. Are there any advantages of color Doppler ultrasound (right image) over compression sonography in the diagnosis of DVT?

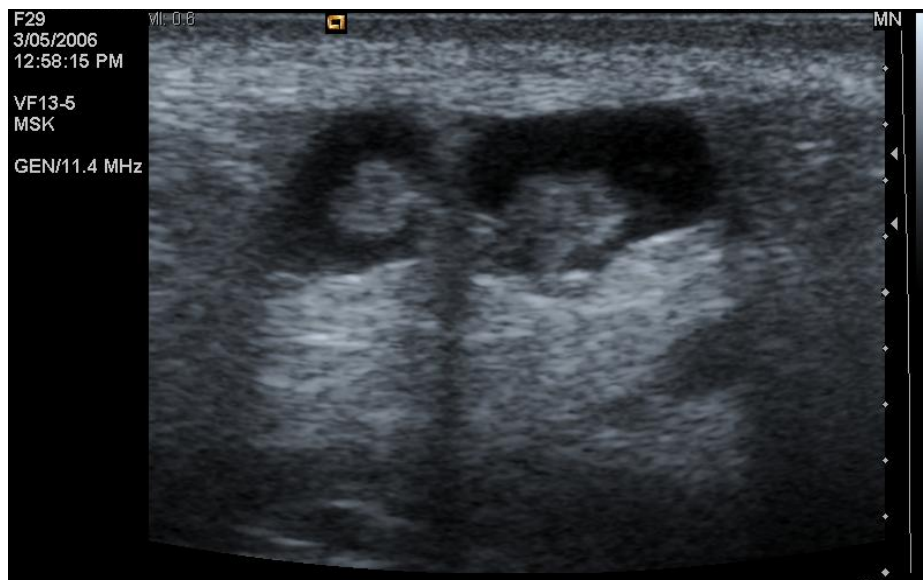
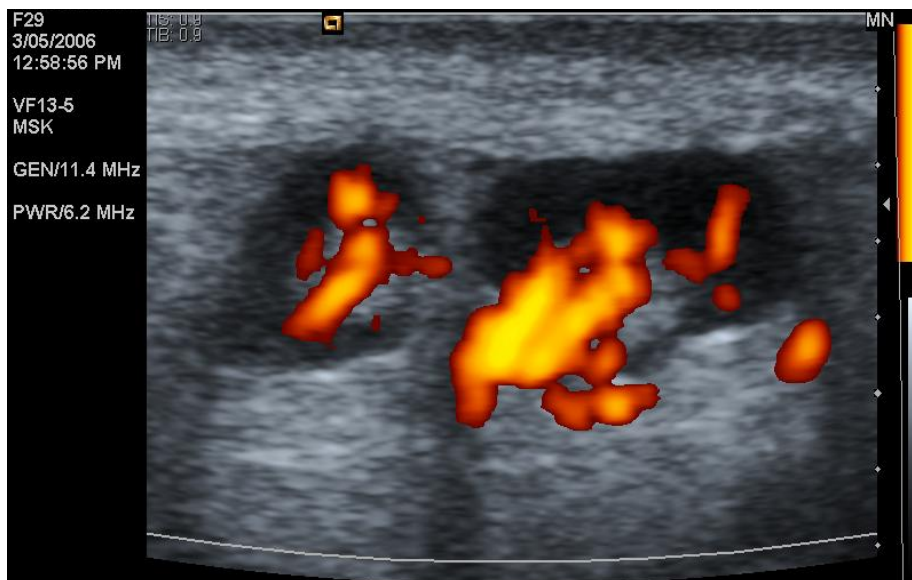
Model Answers: Two lymph nodes are shown with mildly thickened cortex and increased vascularity. Appearance is suggestive of reactive nodes, but the appearance is non-specific.

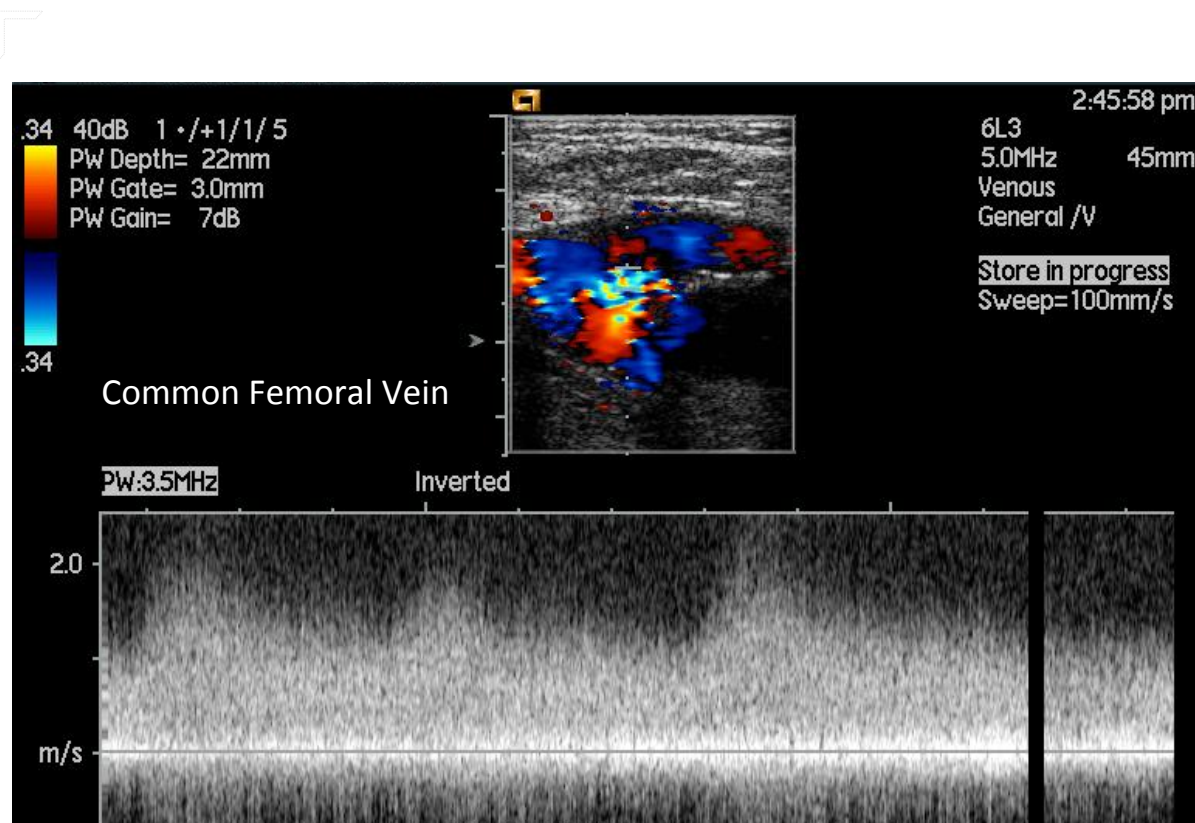
Model Answers: The CFV demonstrates high velocity turbulent arterialized signal. This is a classic finding for AV fistula. On questioning, the patient revealed the leg swelling came on after cardiac catheterization. This is undoubtedly an iatrogenic AVF.
